OSWEGO RIVER BASIN
JENNINGS POND DAM

TOMPKINS COUNTY, NEW YORK
INVENTORY NO. N.Y. 944

PHASE I INSPECTION REPORT
NATIONAL DAM SAFETY PROGRAM
JENNINGS POND DAM
N.Y. 944
DEC I.D. NO. 75C-768
OSWEGO RIVER BASIN
TOMPKINS COUNTY, NEW YORK

Date of Inspection: March 26, 1981 and June 3, 1981

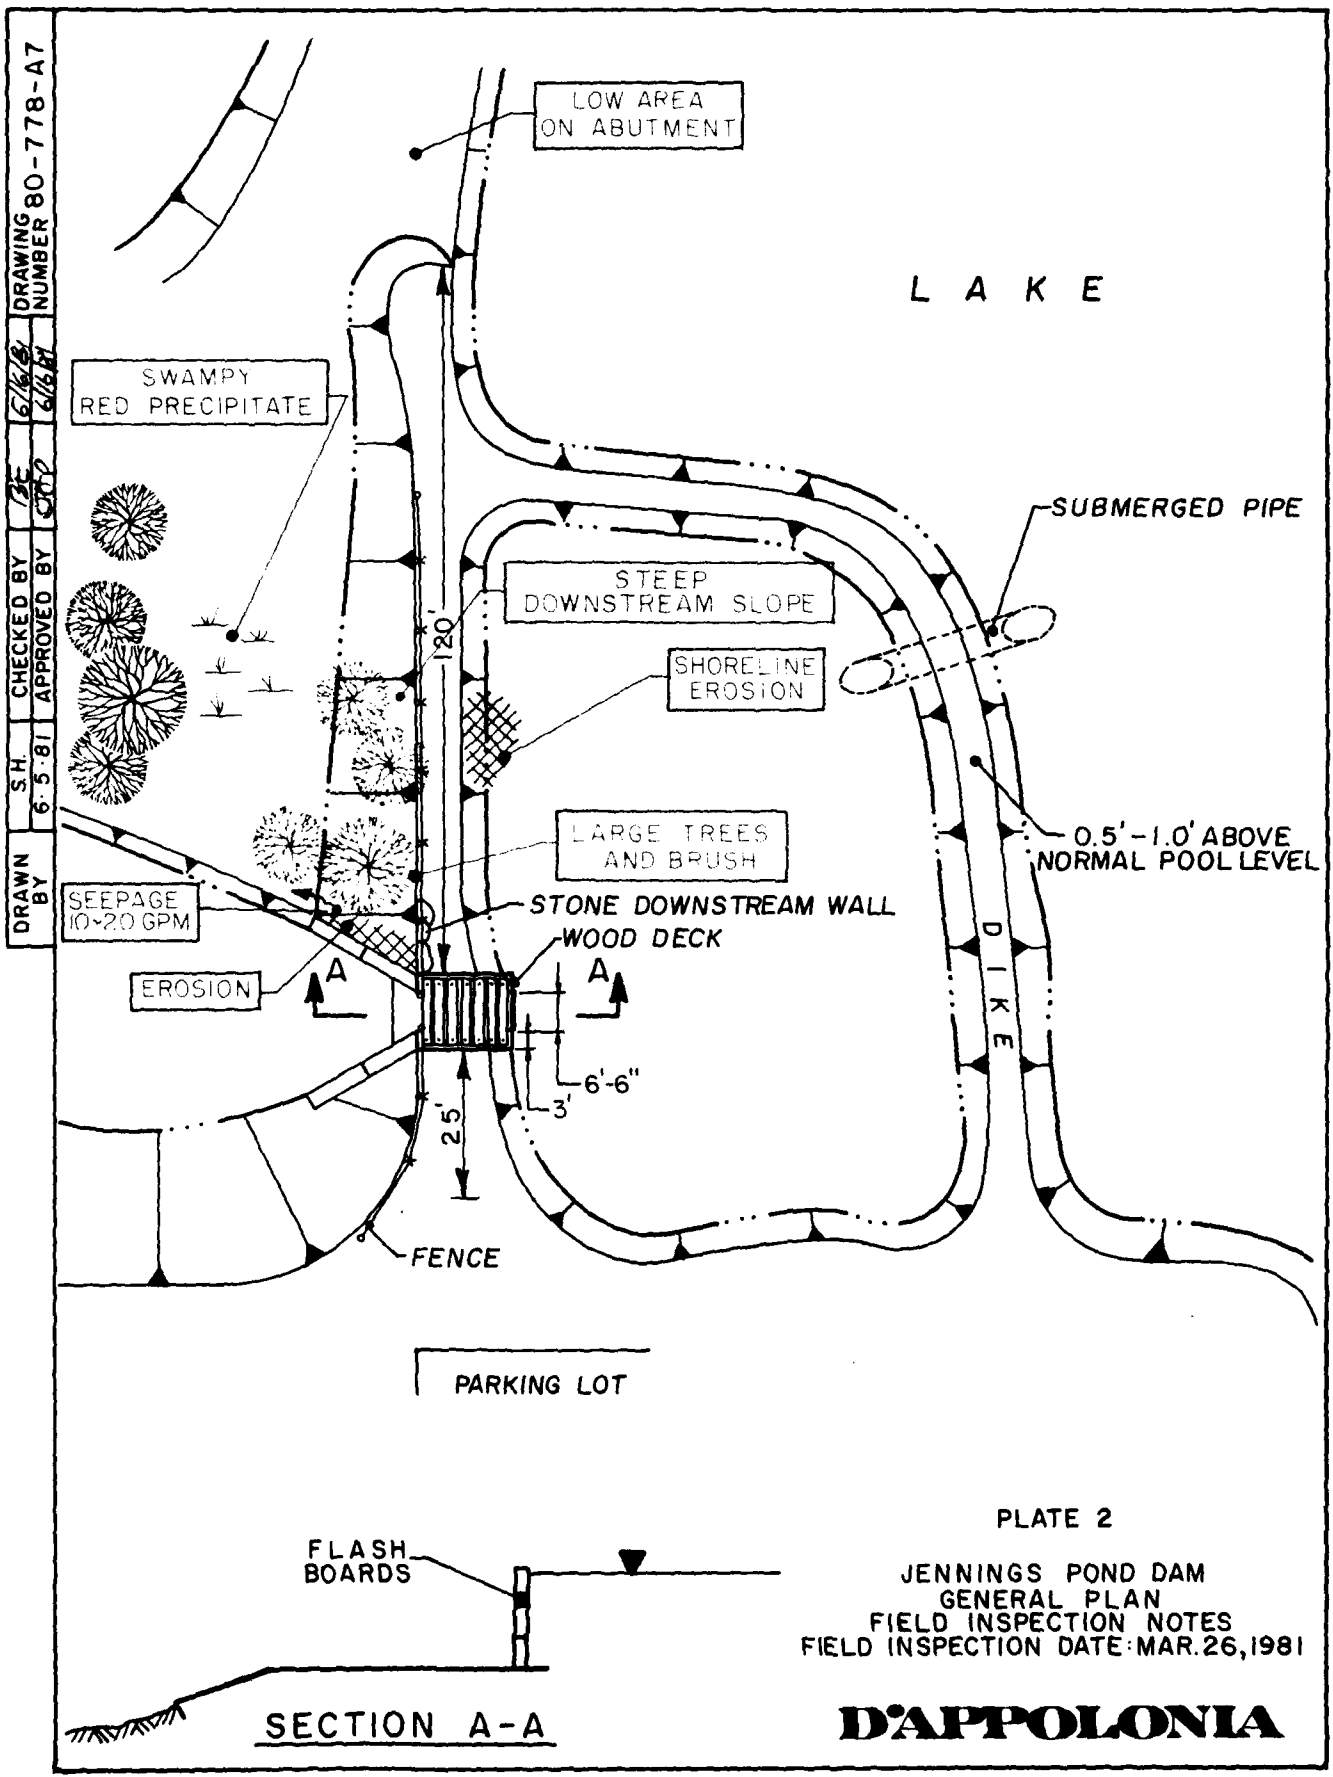
PLATE 2
JENNINGS POND DAM
GENERAL PLAN
FIELD INSPECTION NOTES
FIELD INSPECTION DATE: MAR. 26, 1981

Field observations are illustrated in Plate 2. The downstream face of the dam is steep and covered with large trees and brush. The downstream slope is estimated to be in the range of 1.5H:1V to 1H:1V. A swampy area exists below the downstream toe of the dam; however, no measurable seepage was found to be associated with this area. A seepage point was found at the interface of the embankment and the right wing wall of the spillway structure. The quantity of the seepage is estimated to be in the range of 10 to 20 gallons per minute. The top of the dam was surveyed relative to the spillway flashboard crest elevation and was found to be irregular, ranging from 0.6 foot to 2 feet above pool level. The lowest area is located on the right abutment. A parking area located on the left abutment is also below the average dam crest level by about 0.5 foot.
